eISSN: 2589-7799 2024 May; 7 (5): 5-17

# Influence On The Environment In The Lima Megalopolis, Of The Mining Tailings Located In The Middle And Headboard Basins, Of The Chillón, Rímac And Lurin Rivers. Left By The Exploitation Of Metallic Mineral Resources.

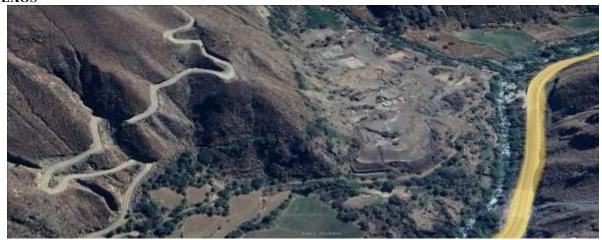
Pasivos mineros Huamantanga

We verified that a part of the mining tailings left by the flotation treatment of sulfide substances containing metallic elements in its concentrator plant with a capacity of 500 tml/day, are still stored on site, its central point identified with UTM coordinates zone 18, N 8723484 E 313317 height 1784 meters above sea level, the area is located at km 82, of the Lima Canta road, right bank of the Chillón River downstream. This solid waste is protected by an irregular perimeter concrete parapet 3 meters high, 60cm at its crown and 150 meters long. Another parapet parallel to this structure 10 meters away, with a mixed texture between concrete and cyclopean rocks, surrounds it. an old transport route whose embankment is partially covered with vegetation such as grasses and bushes, at the foot of this wall, the axis of the Chillón River is 100 meters away and its sector or area is covered by molles, guarangos, bushes and grasses as well as everything The area located in the delta that limits it to the perimeter of the old camp, warehouses, includes the mining tailings, when calculating its area by metric measurements in situ, 1'000,000.00 cubic meters, we take a sample of all the layers decanted by the treatment or management that was given to them in 1985, their spontaneous recovery and due to the passage of time that they have decanted it packed and caked, we had the sample analyzed geochemically for 30 elements, we also prepared a briquette from it to analyze it with the metallographic microscope, part of the result geochemistry of the contaminating elements was as follows:

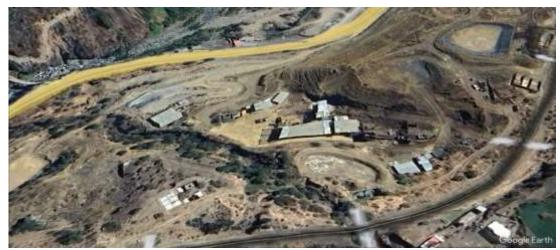
Pasivos mineros mina "El Varón"

Through on-site inspection we corroborated that the mining tailings are still in the process of accumulation due to the current extraction of sulfides that are processed in their 100 t.m.l/day concentration plant that occurs by flotation, obtaining concentrates of metallic elements gold, copper, silver, lead, zinc. The extraction was from the years 1960 to 2024, they still remain partially stored at km 85 of the central highway of Peru passing the city of Matucana, a location given by the coordinates UTM zone 18 N 8693496 E 352429 height 2565 meters above sea level are located between the central track and the cauville line of the Central Railway of Peru, left bank downstream of the Rímac River, on an old river terrace that is part of the left sector of the river, the mining tailings were treated with oxide of lime, forming caliches that are layer upon layer and thus partially mitigates the wind erosion that is strong especially in the evening but not the pluvial erosion, as it shows that a torrent took a part of these mining tailings to the Rímac River and on its bed, a concentrator plant of 100 t.m.l/day has been installed to portray these mining tailings that still have silver, copper and zinc values when, the physical event occurred, the tailings deposit was divided into two sectors, its accumulation dates back to 40 years of existence approximately 1000,000 cubes resulting from a concentrator plant of 500 t.m.l/day, from the mining tailings we extracted two samples to carry out their geochemical analyzes in the Plenge mineral laboratory, we also produced 2 briquettes for petrographic study.

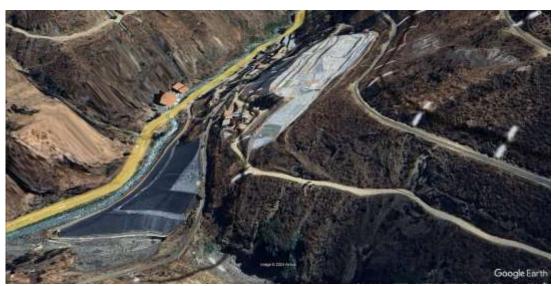
Pasivos mineros "Mina Tamboraque"

Through on-site inspection we corroborated that the mining tailings are still in the process of accumulation due to the current extraction of sulfides that are processed in their concentration plant of 1000 t.m.l/day, it is by flotation and gravity for 1000 t.m.l/day, where it is treated and obtained. concentrates of metallic elements gold, copper, silver, lead, zinc. Extraction that occurred from the years 1960 to 2024, they remain still partially stored at the height of km 85 of the central highway of Peru passing the city of Matucana, a place given by the coordinates UTM zone 18 N 8696989 E 357573 height 2952 meters above sea level. over the river and the cauville line

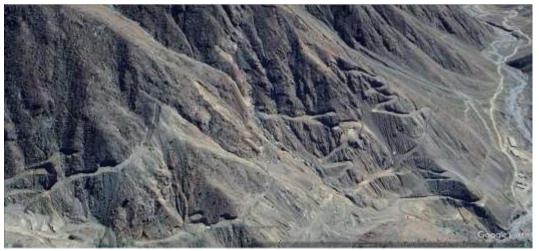
PROYECTO MINERO PALMA.

By evidencing the physical processes and activities carried out by man in situ, we corroborate that the waste from diamond drilling and old mining tailings resulting from the exploitation of the VSM La Palma mineral deposit, as well as the accesses and platforms used for its exploitation and the solid waste generated , are still a testimony of the exploration and exploitation activities of mineralized substances within sulfides such as black zinc or marmatite. For this activity, a concentrator plant of 500 t.m.l/day by flotation was used, in which concentrates of metallic elements copper, silver, lead, zinc. The extraction took place in the 1980s, height of km 60 via Cieneguilla Antioquía Huarochirí, La Palma Occurs location given by the UTM coordinates zone 18 N 8667434 E 329502 height 1295 meters above sea level.
