## Exploring the Impact and Lessons of the 2019 Kavalappara Landslide Disasters in Kerala, India: A Field Observation Analysis

### Abstract

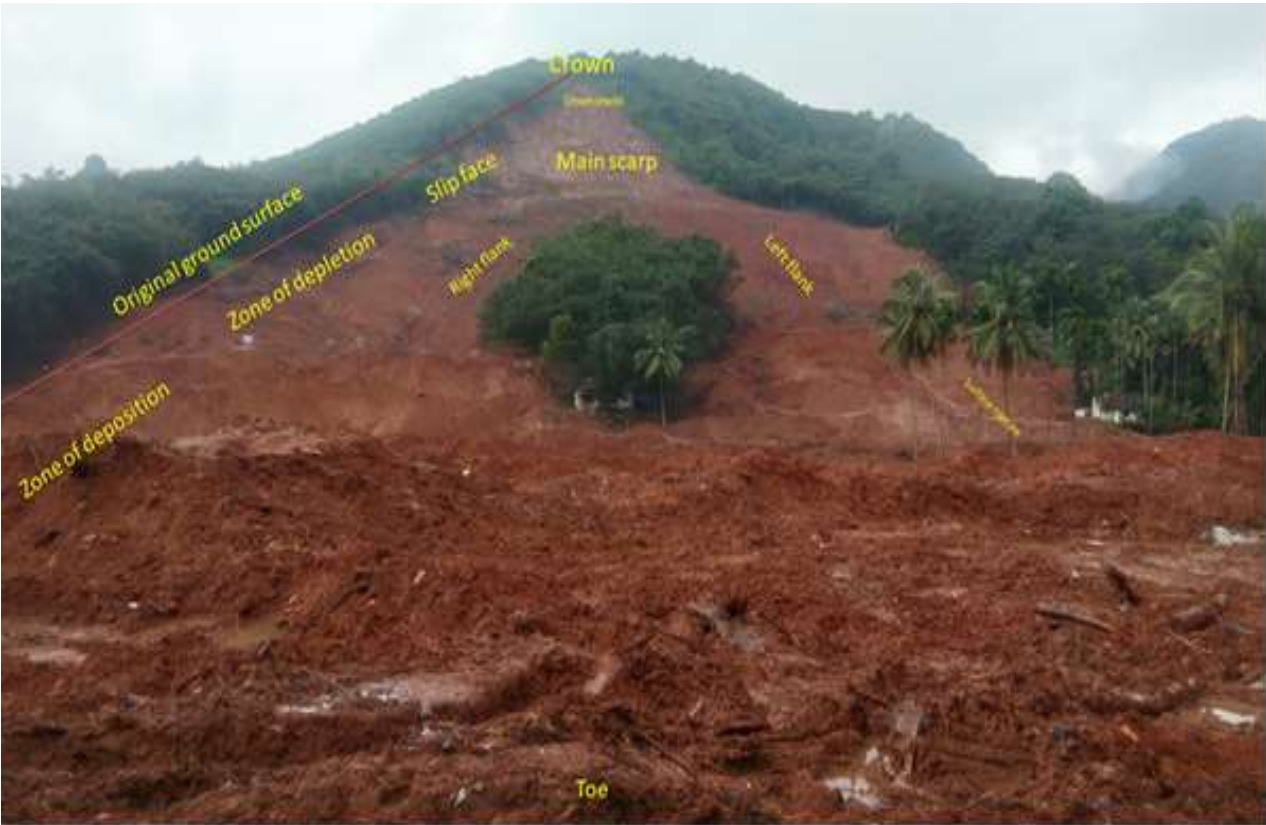
**Figure 2      Cross section of Kavalappara landslide.**

The landslide at Kavalappara originated from the northern slope of the 350-meter-high Muthappan hill. Figure 4. The landslide was triggered when a mud block measuring 3 meters in thickness began moving downward from 300 meters. As it descended, it accumulated loose soil and rocks along its path, eventually resulting in the devastating landslide that impacted the area. The steep terrain and the accumulation of debris made it challenging to mitigate the effects of the landslide, leading to significant destruction and loss of life. Landslides are complex geological events influenced by various factors, including topography and weather conditions.

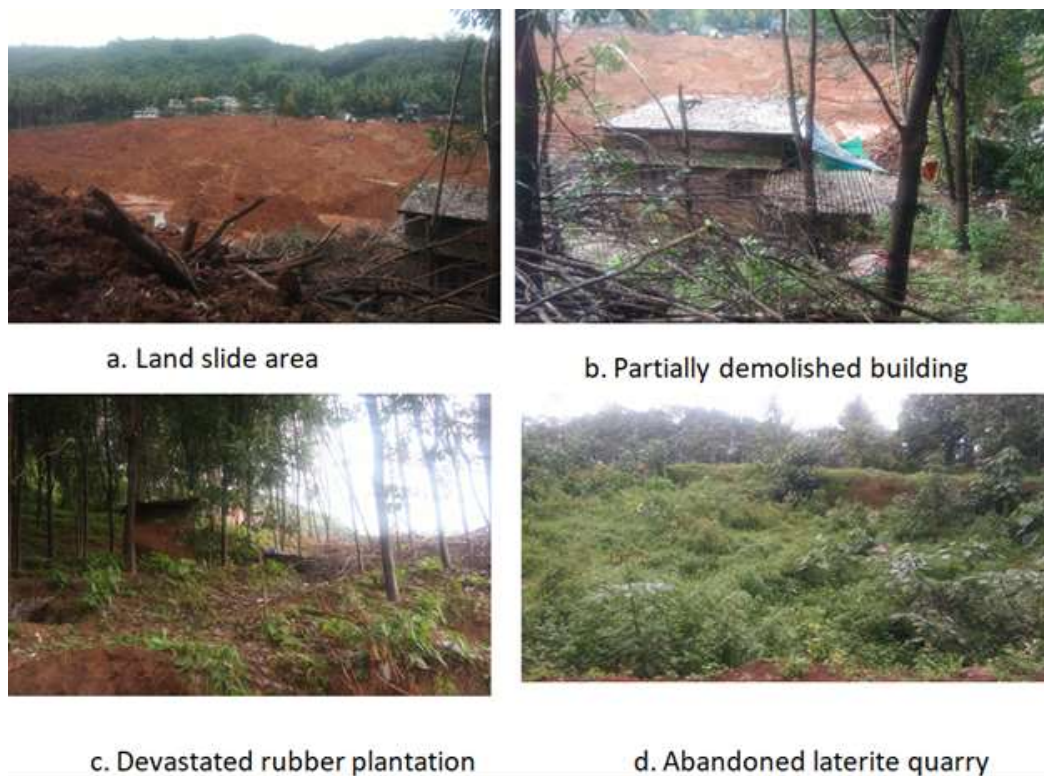
**Figure 5 Field photograph of Kavalappara landslide areas**

Figure 5 shows that the mechanical alteration of the terrain for rubber cultivation further exacerbated the situation at Kavalappara. The process of creating pits for the rubber plantation had a significant impact on the natural landscape and soil structure. The crown portion of the main slide area of Kavalappara is an uninhabited hillock with frequent intense tillage for rubber plantations(Chattopadhyay Srikumar2015). Moreover, the construction of terraces using random rubbles in the rubber-cultivated area results in the blockage of free passage of water, leading to the increased infiltration of water (Naidu Shruti, 2018).

The pits dug for rubber cultivation significantly altered the soil structure in the area. This type of mechanical disturbance can change the soil's composition and stability, making it more vulnerable to erosion and landslides. Water that entered these pits due to heavy rainfall had its natural flow patterns disrupted. Instead of percolating into the ground, it remained on the surface. This increased surface water flow can lead to soil erosion and contribute to landslides. Rubber cultivation in problematic areas with varying slopes is more likely to increase the risk of landslides due to intensive monoculture practices (Winai Wangpimool, 2017). The area had a relatively shallow topsoil depth of only 2 meters. When this limited topsoil is disturbed, it can expose the underlying rocky layers. The soil in the area was held together by lethargic clay, which played a critical role in stabilizing the terrain. However, the steady percolation of water, especially due to the blocked drainage channels, diluted and washed away this clay, weakening the bond between the rocky base and the topsoil. The combination of these factors, including the altered soil structure, surface water flow disruption, and the weakening of the lethargic clay, collectively increased the risk of a landslide. This highlights the importance of responsible land use practices and the potential environmental consequences of land development in geologically sensitive and hilly regions.
